**BRACKENRIDGE ESTATE**

**ENVIRONMENTAL CONTROL OFFICER REPORT**

**Report: # 1**

**Period: 1 May to 31 May 2024**

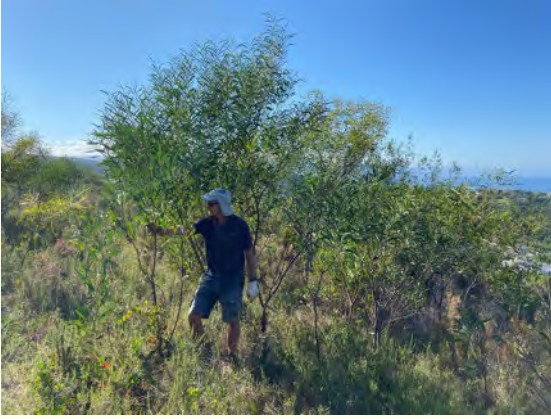
A Port Jackson-infested section along the contour path above Orchid Valley.

The EMC have also begun IAS removal above Orchid valley and to date have removed over 90 Port Jackson (*Acacia saligna*) in a three hour period. More hacking days will be schedule each month and any residents interested in becoming part of the hacking team are invited to contact the ECO.

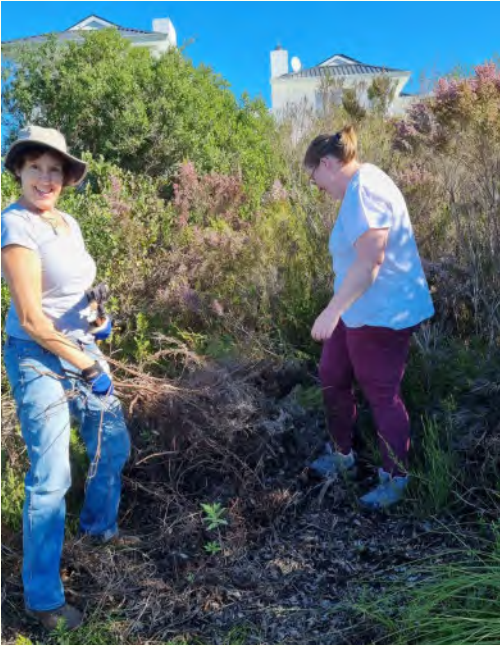
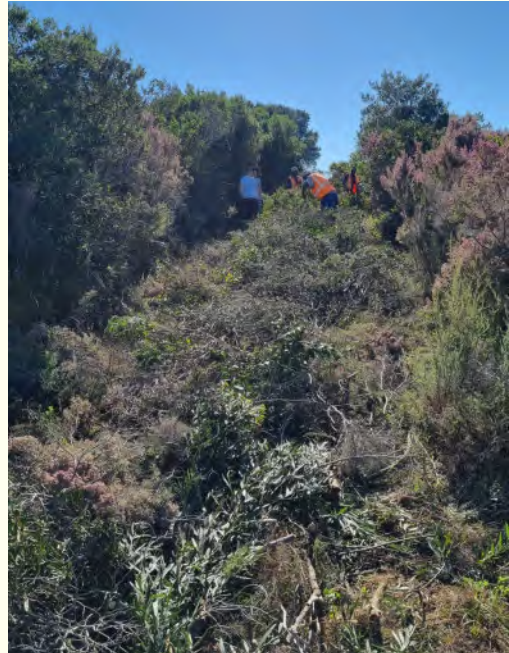
Opening of overgrown maintenance road.

**Roads:** Eldred and his team are currently maintaining roads and reopening overgrown roads to avoid unnecessary roads or vehicle access paths to restore them back to their natural Fynbos habitat. The ECO will work with the team to restore areas where the road is wider than necessary, returning them back to appropriate widths and allowing regeneration of the vegetation.

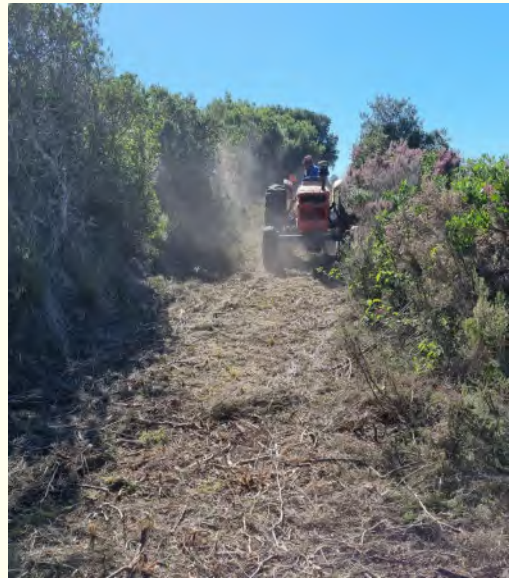
Area behind tractor will be rehabilitated to natural habitat.

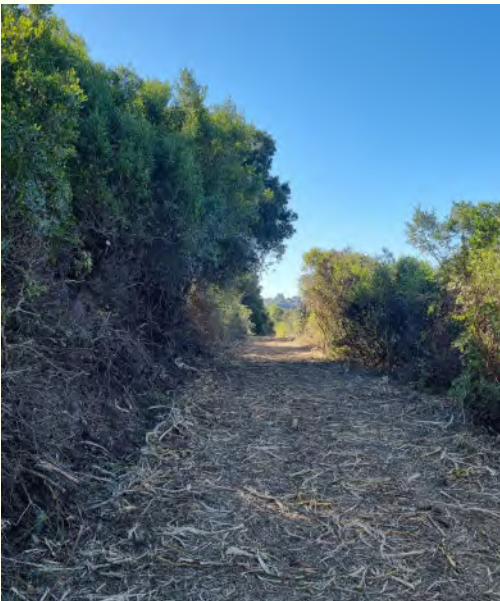
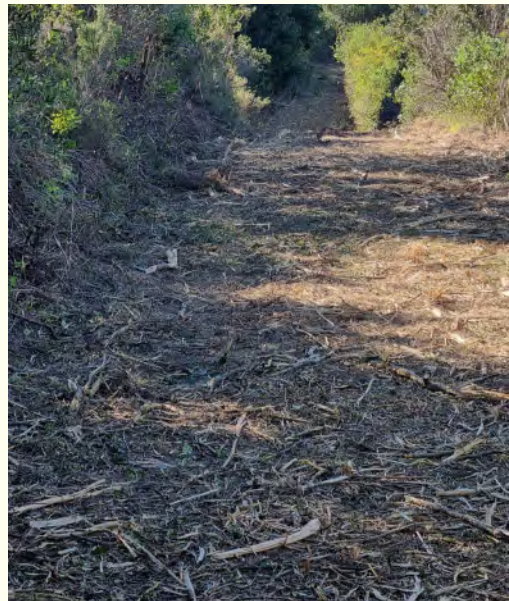
Tractor mulching debris.
