BRACKENRIDGE ESTATE

ENVIRONMENTAL CONTROL OFFICER REPORT

Report: #4

Period: 1 August to 31 August 2024

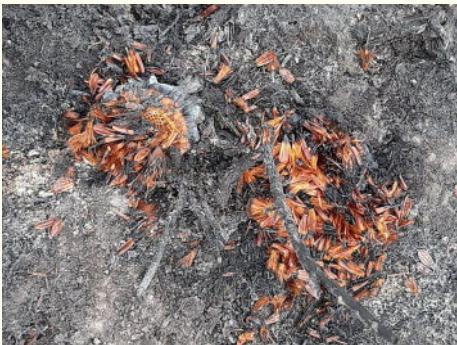
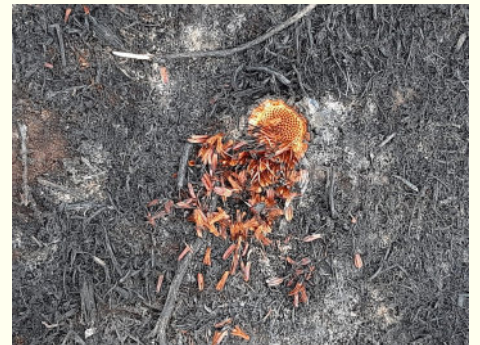
There is already evidence of the success of the prescribed burn in block 5. A number of Protea cones have burst open and dropped seed.

On the 7th of August the contractors began digging the trench to lay the gravity feed pipeline for the reservoir. The route for the pipeline was marked out with the contractor, general manager and chairman of the EMC the week before. The goal is to limit the amount of disturbance in the burnt area of block 5 by sticking to a designated area with the heavy equipment.

Once the pipeline is complete the ECO will assess block 5 and determine if further intervention is required to assist with the rehabilitation of the area.

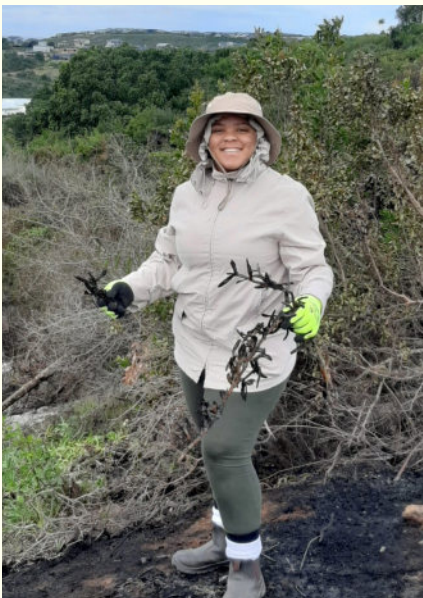
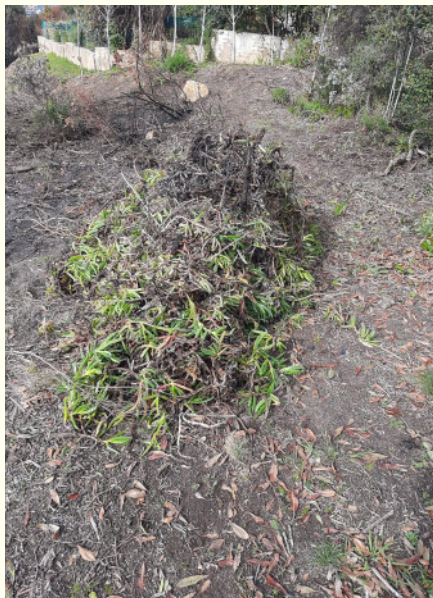
The Home from Home team completed clearing of the breaks on the 6th of August and will turn their attention to the removal of the sourfig from the burnt areas of block 6. The ECO with the assistance of an intern from NewBridge Graduate Institute have begun to remove the larger sections of sourfig, which will be collected by the Home from Home team and taken to the composting area.

Sourfig removal

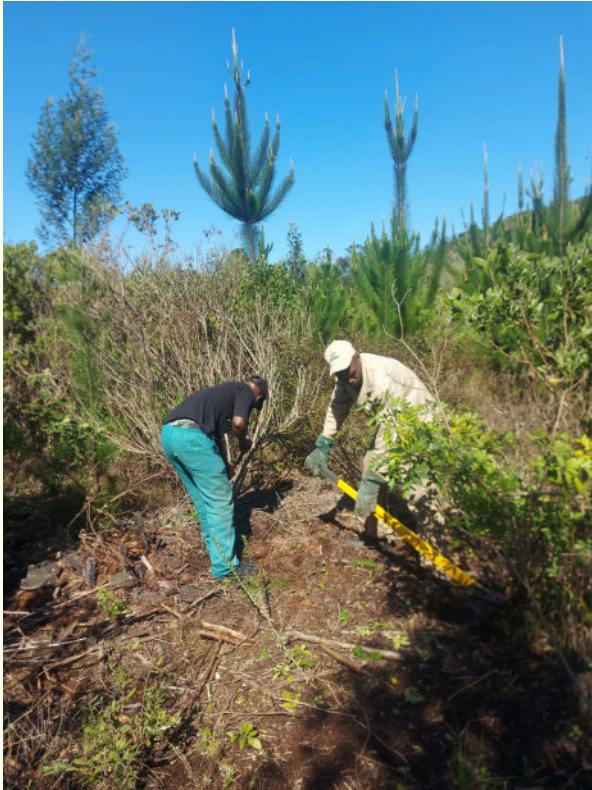
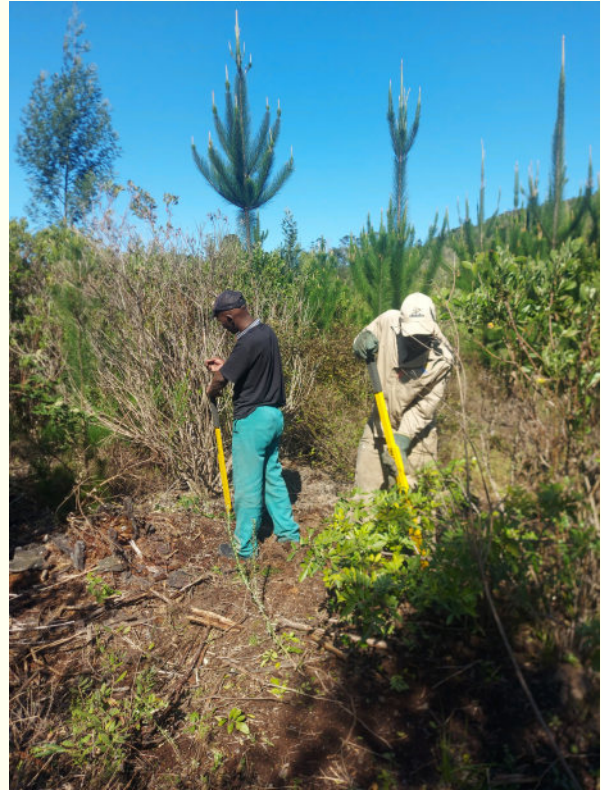
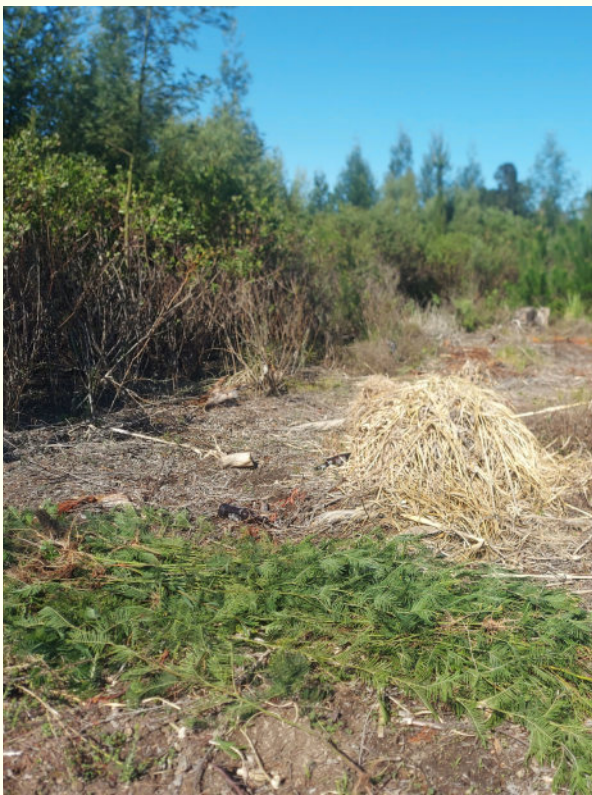
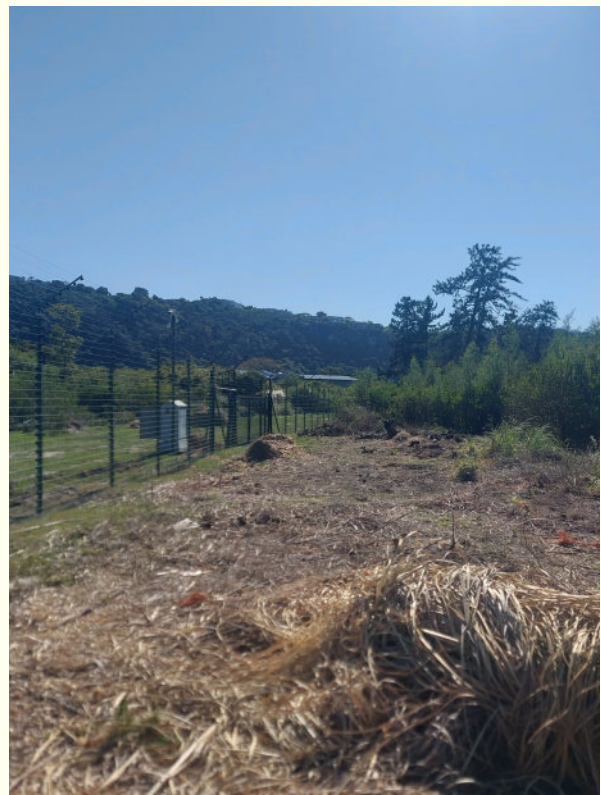
Eldred and his team continue to clear along the fence line, removing and chipping all invasive species they encounter during the clearing.

Removal of alien invasives along fence line.

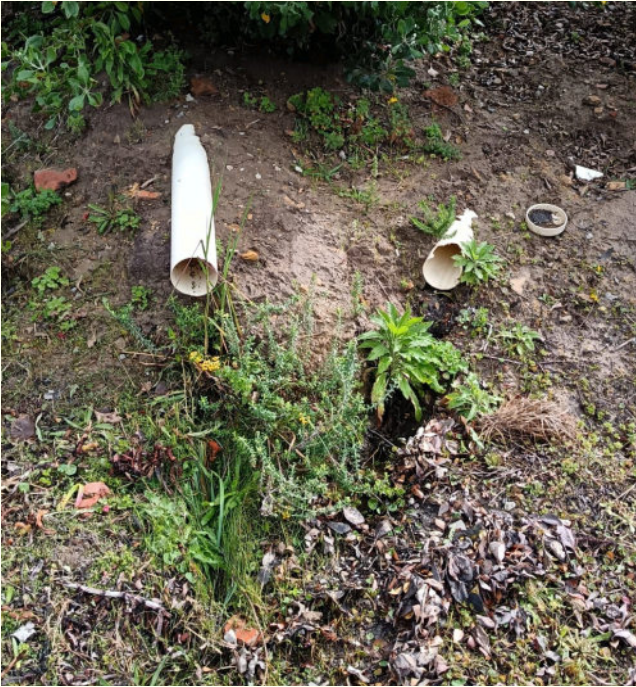
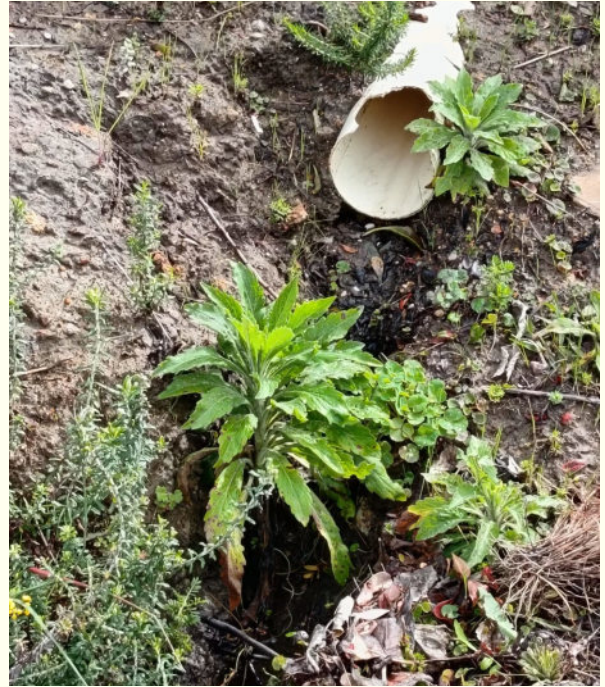
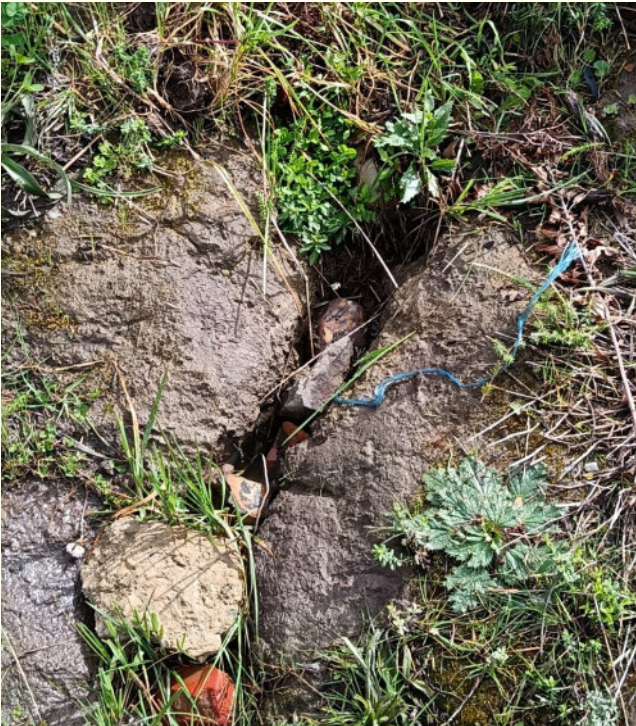
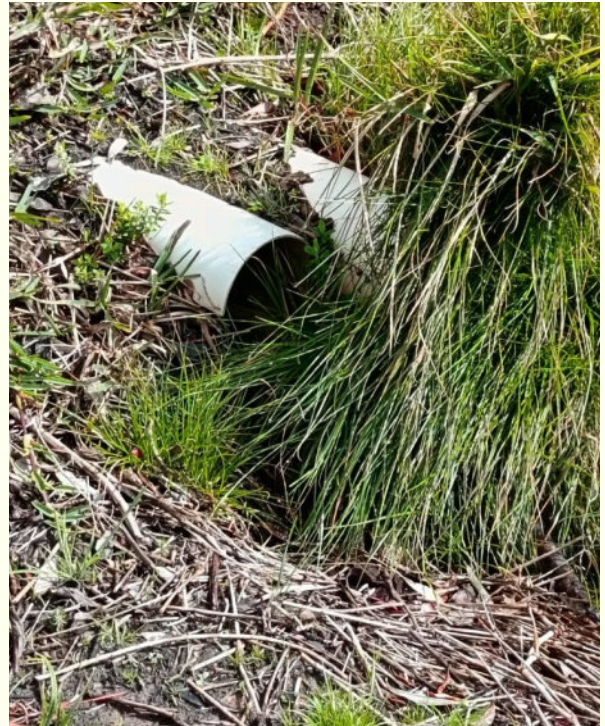
In block 6, along parts of the fire breaks erosion rills are starting to form and some areas have washed away soil, resulting in deep erosion rills forming which will eventually lead to deeper dongas.

Erosion due to storm water outlets in block 6.

The ECO along with the estate management request residents to please address issues with their storm water outlets as soon as possible. Letters will be sent out to residents whose outlets are a problem, along with photos showcasing the problem and potential solutions to help mitigate the issue.

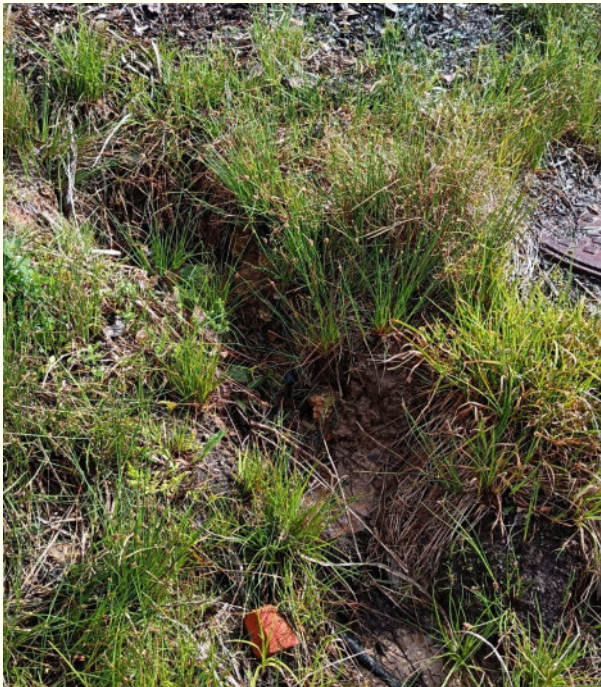
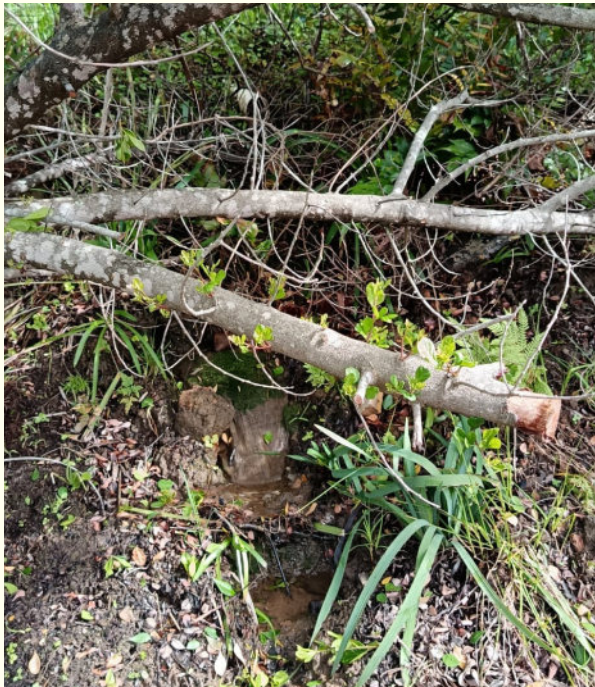
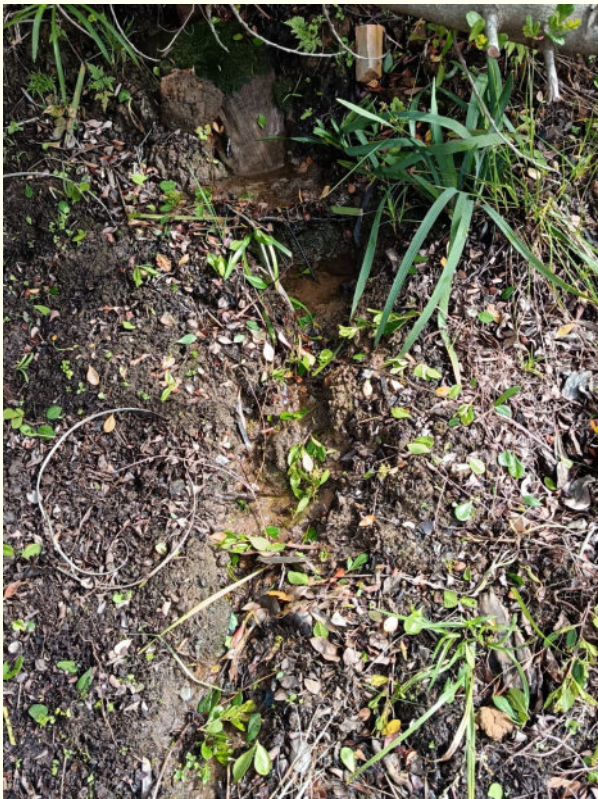
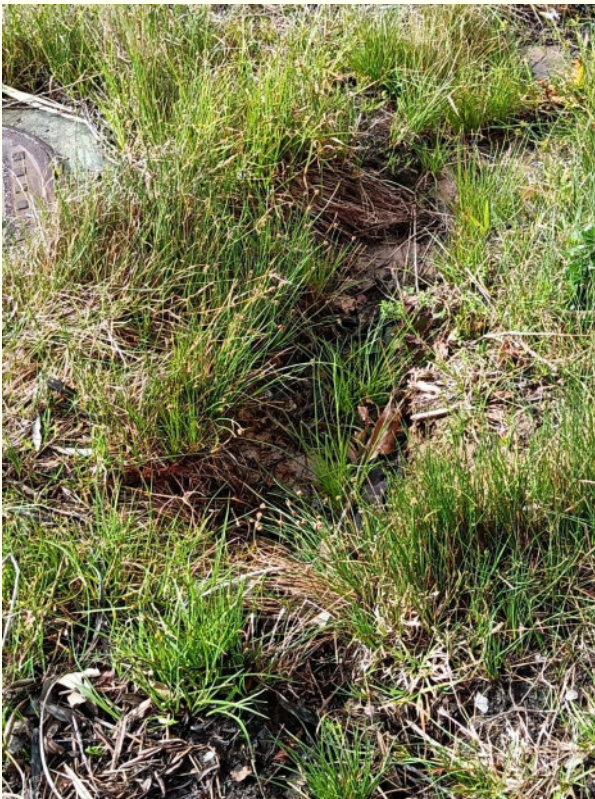
Erosion due to storm water outlets in block 6.
