An Environmental Audit of Brackenridge Estate

Prof. Patricia M. Holmes (PhD)

20th October 2023

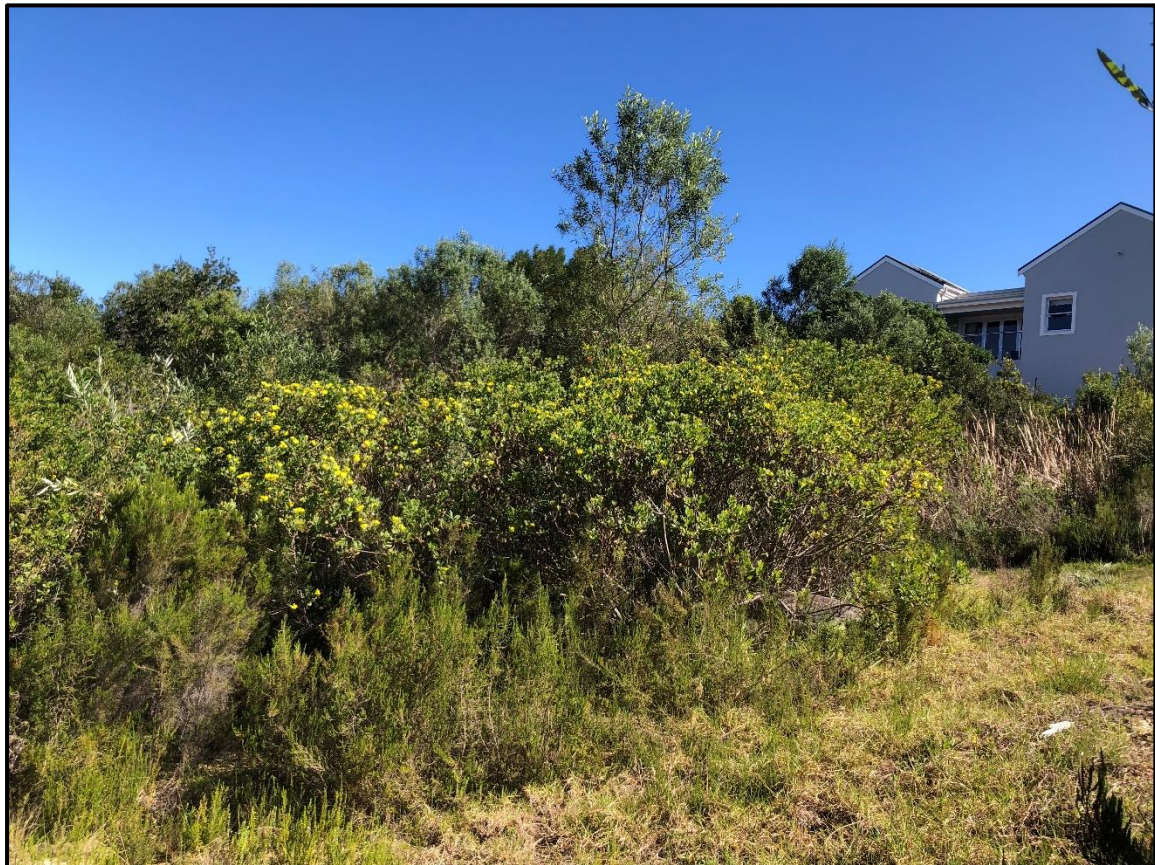
Photo 1. Interface between housing and old Fynbos vegetation at Brackenridge Estate

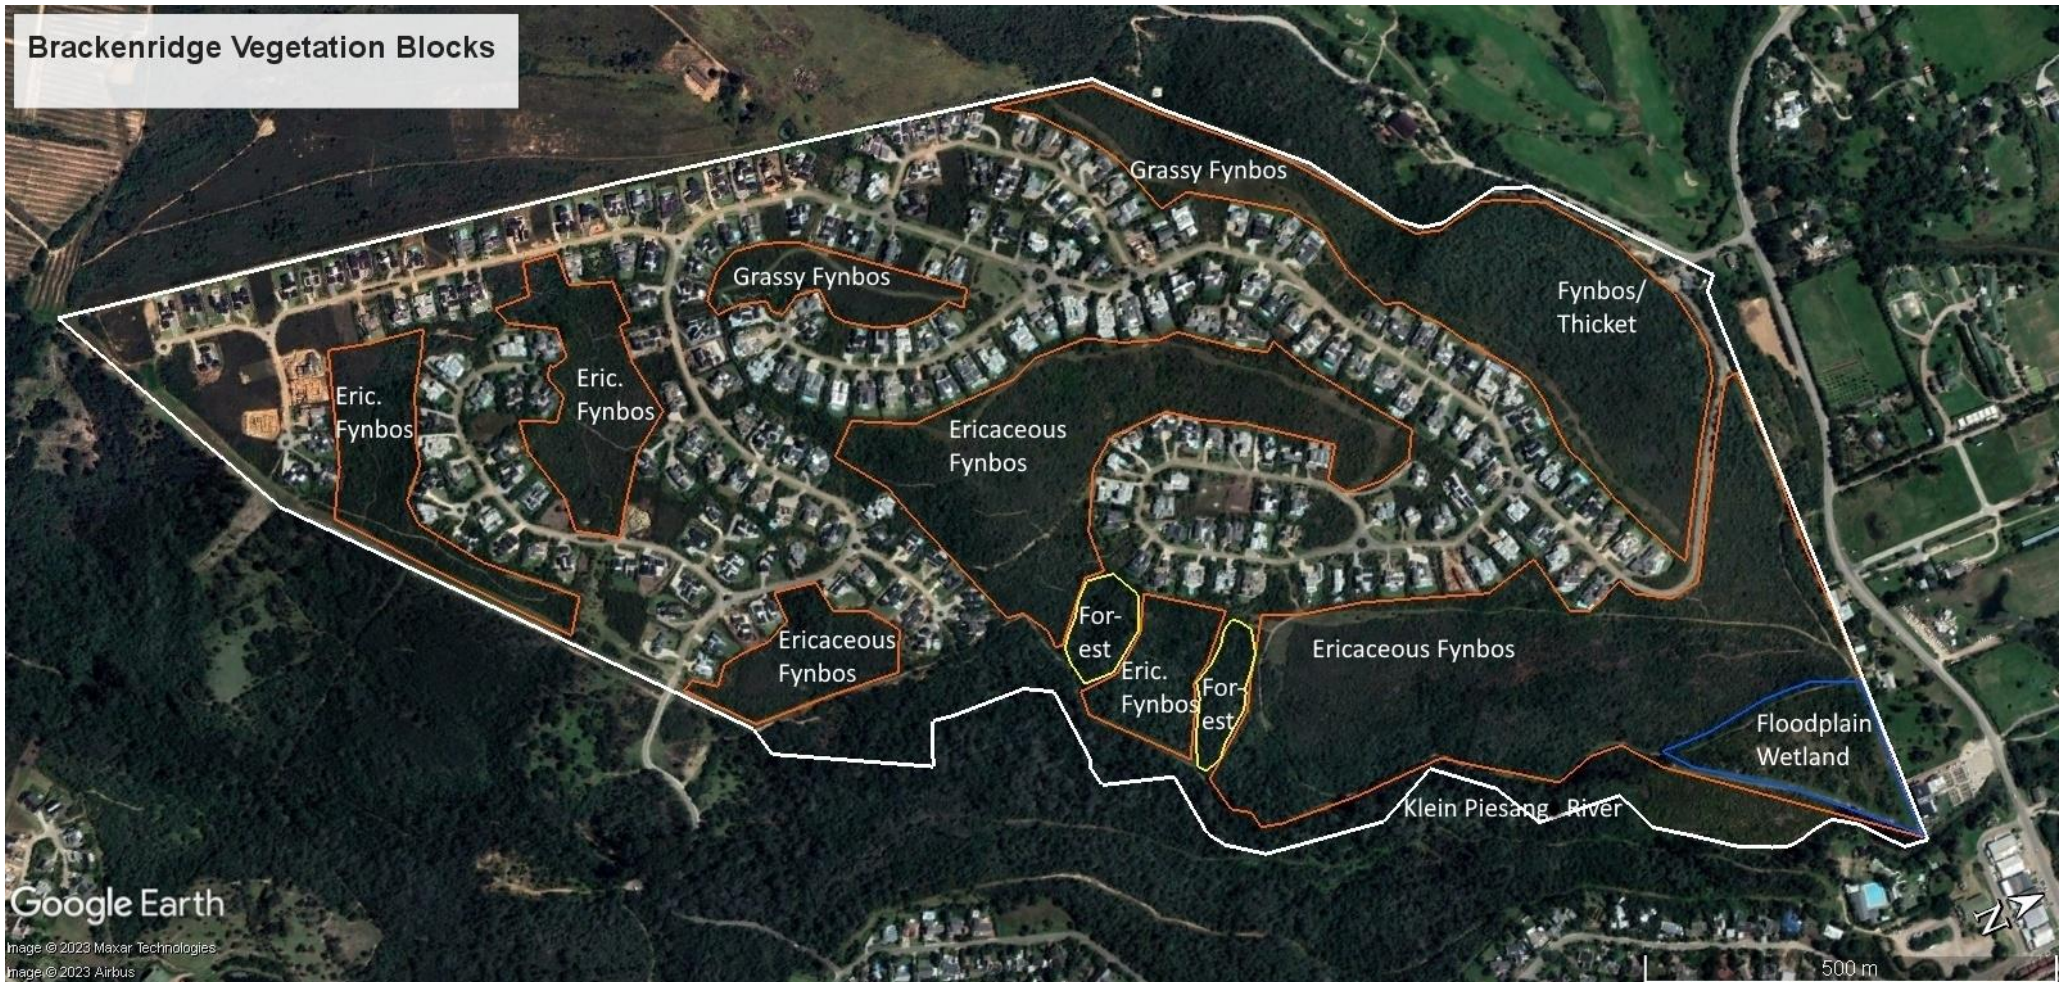
Figure 1. A recent Google Earth image of Brackenridge Estate indicating the main vegetation blocks in the natural open space areas. Note that the western banks of the Klein Piesang River outside of the fence are also part of the Estate and historically would have comprised a Fynbos Riparian Scrub plant community.

According to the OEMP (2001), prescribed burning should be used as a management tool for the benefit of Fynbos conservation and to prevent or minimize damage to the development and adjacent properties as a result of wild fires. No prescribed burns have been done to date and vegetation age currently is in excess of four decades. This poses a fire risk to properties as well as a risk of biodiversity loss. Fynbos seed banks can persist in the soil for at least three decades, but as this fire-free interval increases more species may become locally extinct. Implementing an ecologically sound prescribed burning plan is required as a matter of urgency. Figure 1. shows an aerial image of the Estate with the major vegetation units labelled.

Directive: Draw up an “Integrated Fire and Alien Species Management Plan”. This plan should:

- Delineate the burning blocks and prioritize blocks for burning (including proposed dates),
- Outline fire preparation requirements and post-fire requirements,
- Be updated regularly by the Environmental Conservation Officer (ECO) as an “Annual Plan of Operation” following consultation with the Environmental Management Subcommittee, Fire Protection Association representatives and Estate Management.
- Apply for an ecological burning permit well in advance of the proposed burning date to allow for all permissions to be aligned (e.g., Air Pollution Control approvals; local Municipality; approvals from adjacent residents and neighbouring landowners).
- Appoint an experienced operational fire team, with experience in Fynbos burns, to conduct the prescribed burns.

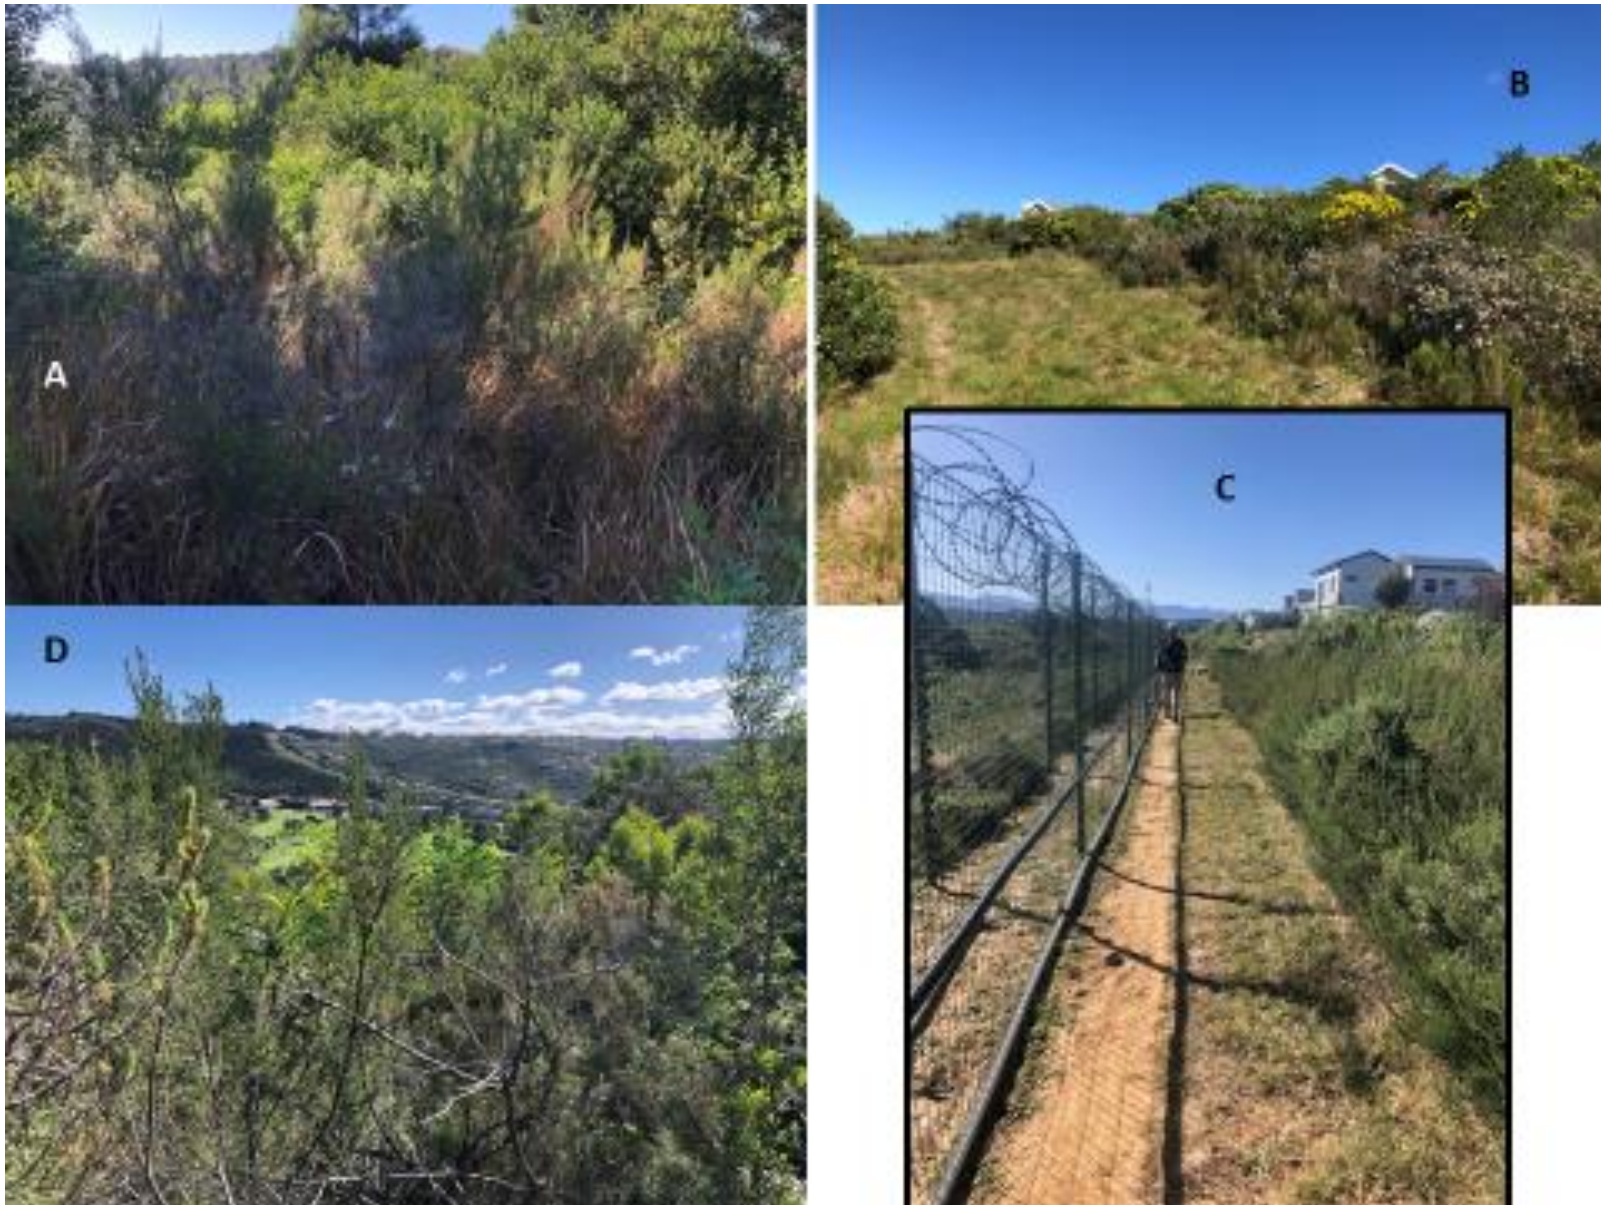
Currently the Estate fire belt system is not comprehensive as it does not span the entire housing - natural open space interface and in some cases is positioned away from the boundaries of housing (by up to 20 m) allowing tall, moribund Fynbos vegetation to grow between the fire belt and the immediate borders of the houses. This also fragments the Fynbos remnants unnecessarily. Furthermore, some fire belts have grown up and require re-cutting (e.g., on the slopes below Watsonia Heights). Although fire belts of any size will not stop embers spotting from a runaway wild fire under severe weather conditions, they are important to halt ground fires, for quick access points in fighting fires or to initiate back-burns, and are necessary for implementing ecological prescribed management burns.

As the majority of the open space on the Estate comprises the Endangered Garden Route Shale Fynbos vegetation type, ecological prescribed burning is necessary to conserve this biodiversity (Holmes 2023). Fynbos is fire-prone and fire-dependent: without fire this rich and Endangered biodiversity will be lost. Owing to fire exclusion for the past four decades or more, this Fynbos is moribund and has become invaded both by alien woody species and indigenous Thicket and Forest trees and shrubs. This has created a dangerously high fuel load that is also flammable. A wildfire occurring under severe weather conditions in this vegetation state would be extremely difficult to extinguish or control.

Photograph panel 1. Illustrates A. Moribund Fynbos vegetation invaded by Thicket shrubs and trees; B. Fire belt positioned away from housing; C. Narrow space between gardens and boundary fence (Erica Heath); D. Fynbos invaded by alien trees.

Directive: Review and improve the current fire belt system to:

- Create a continuous belt between housing and natural vegetation areas;
- Relocate current fire belts cut away from housing borders to be adjacent to them (e.g., along sections adjacent to Orchid Valley);

- Cut a 5 m-wide fire belt: ideally only 3 m-wide should be cut in the natural open space areas to minimize loss of biodiversity, with the other 2 m cut by the adjacent home owners on their properties (fire management should be a shared responsibility). Fire belts in gardens can comprise cut lawns, low (ankle-height) non-flammable bedding or ground cover plants, paving or, if some privacy is required, a succulent hedge of non-flammable Spekboom (*Portulacaria afra*) or Kranz Aloe (*Aloe arborescens*);

- Improve fire belts where less than a 3 m-wide space is available between the Estate fence and housing, e.g., west of Erica Heath: at least 2 m of adjacent gardens must be landscaped as fire belt along the edge closest to the fence where the adjacent land outside the Estate comprises flammable vegetation;

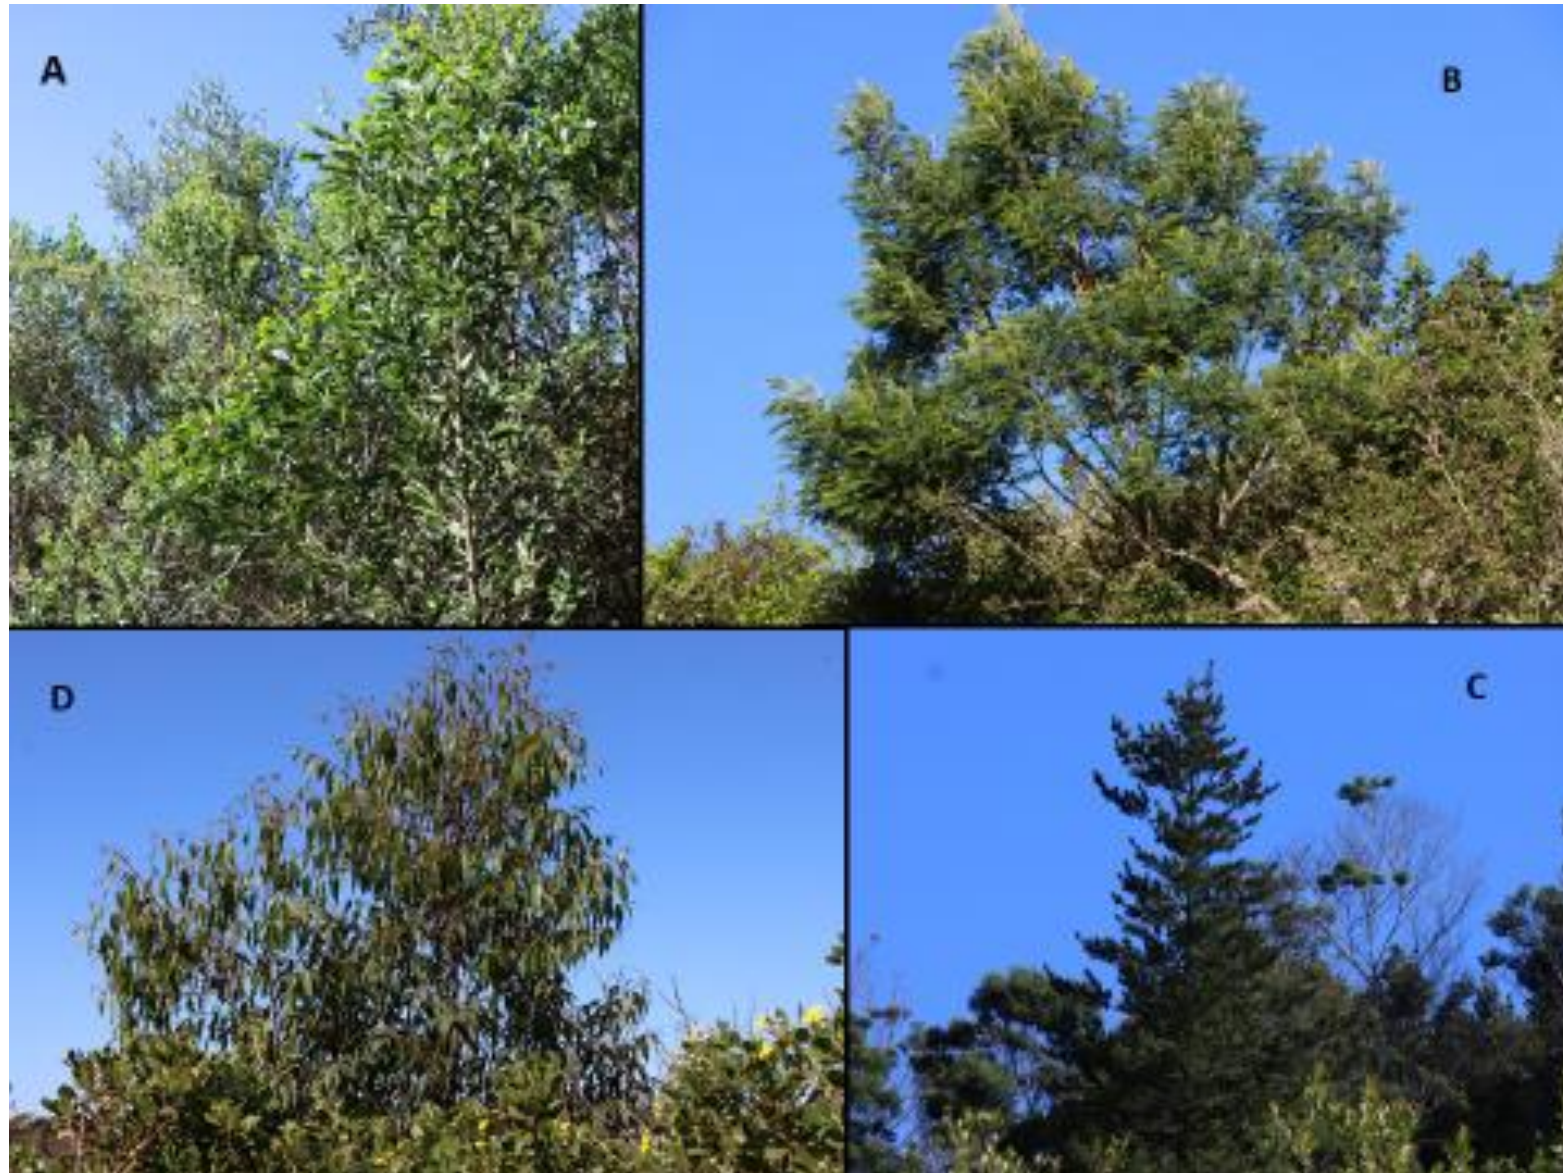
According to the OEMP (2001), all invasive alien plants occurring on site would be removed during the construction phase, with ongoing follow-up control implemented. Clearly alien control has not yet succeeded in reducing the alien invasions to a maintenance level: the biodiversity assessment of the Estate recorded 39 alien plant species, with densities varying from scattered to moderately dense invasion levels, and dense alien stands along the Klein Piesang River (Holmes 2023). The most urgent aliens to control are the invasive species that alter ecosystem processes (e.g., fire behaviour), particularly alien trees in Fynbos, such as wattles, gums and pines. Some *ad hoc* clearing has been done in the past year, but this is insufficient to tackle the twin threats of alien proliferation and increase in woody fuel loads, which present a fire risk to the Estate and to biodiversity. To address this, it is recommended that a subsidiary “Integrated Fire and Alien Species Management Plan” is drawn up and appended to the EMP, to be updated every year as an “Annual Plan of Operation”.

The Riparian vegetation along the Klein Piesang River has all but disappeared under dense stands of tall invasive alien wattles e.g., *Acacia mearnsii* (Black Wattle) and *A. melanoxylon* (Black Wood). It is difficult to describe what plant community would have occurred there historically. In this case some active restoration (i.e., introduction of local riparian species) may be required after alien control to provide ground cover and soil stability and to counter re-invasion by alien species. A list of suitable riparian species for restoration could be drawn up from the nearest natural riparian plant community in the area that occurs on similar geology and soils. As the river is shared with the Municipality, collaboration would be required between them and Brackenridge Estate, perhaps engaging around the proposed “Botanical Park” for the Municipal Commonage property.

Photograph panel 2. Illustrates some invasive alien tree species in Fynbos: A. *Acacia melanoxylon* (Black Wood), B. *Acacia mearnsii* (Black Wattle), C. *Pinus radiata* (Monterey Pine), D. *Eucalyptus* species (gum).

Directive: Draw up an Integrated Fire and Alien Species Management Plan and update annually as an “Annual Plan of Operation” as for 2.1. In addition:

- Include maps of priority invasive species (and an estimate of alien densities to assess workloads and costs) for each burn block.
- Include pre- and post-fire invasive alien species control requirements.
- Appoint a skilled operational team to implement the alien control and fuel reduction (removal) actions prior to the block burn.
- Appoint a skilled operational team to implement the post-fire alien control, ideally when plants are still small enough to be pulled and lopped.

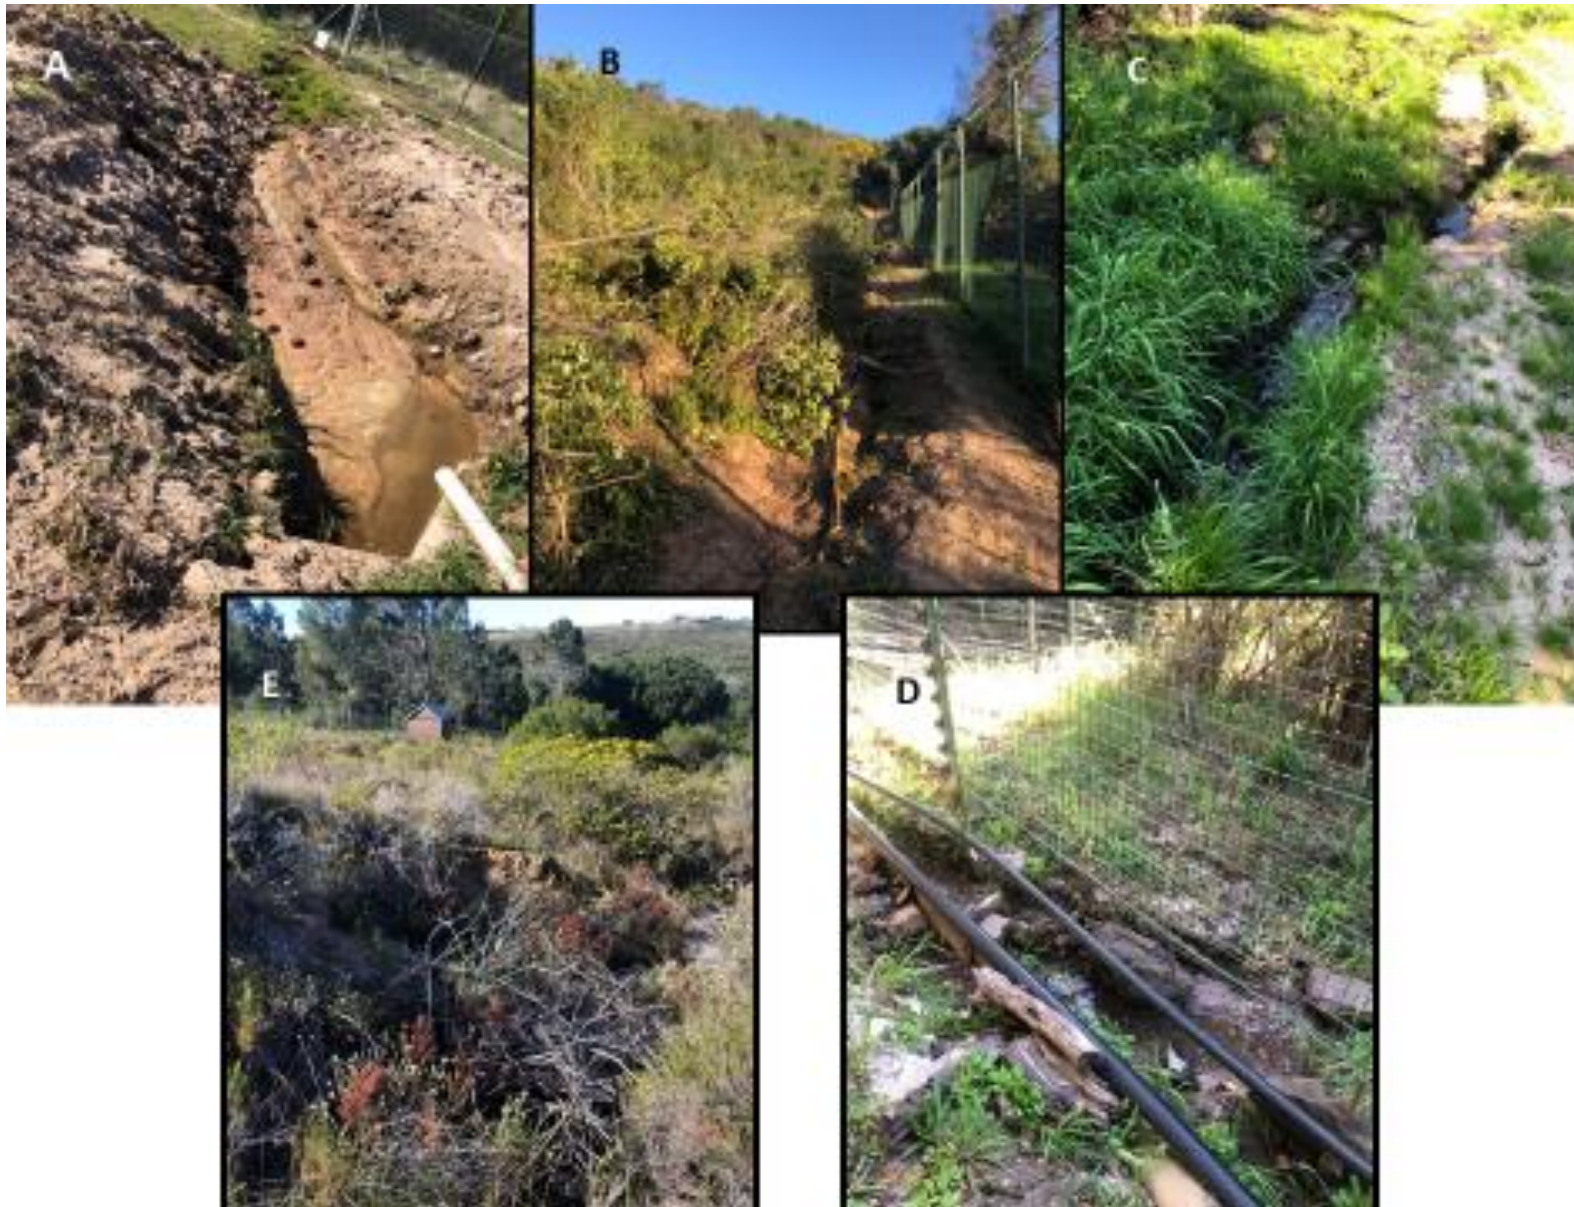
No large areas of erosion were noted during the survey and there were few areas of exposed soil, except where new construction was taking place in the southern section of the Estate. However, cleared footpaths and fence lines are exposed to the erosive forces of heavy rain and some localized areas of soil erosion were noted, for example on a steep slope along the fence line below Watsonia Heights. This erosion had exposed some wiring. Steep areas along the fence line are likely to be prone to erosion and any erosion runnels should be addressed promptly when noted during fence line patrols.

A recently opened storm water culvert in the south of the Estate illustrates the erosive potential of such outlets. For example, another storm water culvert in the SE corner has resulted in a donga being created (photo panel 3).

Photograph panel 3. Illustrates A. Recently opened storm water culvert; B. Erosion runnel on steep slope along northern fence line; C. Erosion runnel down a path in southeast section of Estate; D. Erosion down a path along southeast fence line; E. Erosion donga formed at storm water outlet near southeast corner of Estate.

Directives:

- Patrollers on fence line patrols should take note of localized soil erosion on steep slopes adjacent to the fences so that repairs may be implemented timeously.
- Similarly, the path network and storm water culverts should be checked after heavy rains to note any erosion runnels and implement preventative repairs.
- The SE storm water outlet (Photo panel 3) should be redesigned to spread the outflow more widely to allow rehabilitation of the eroded donga area.

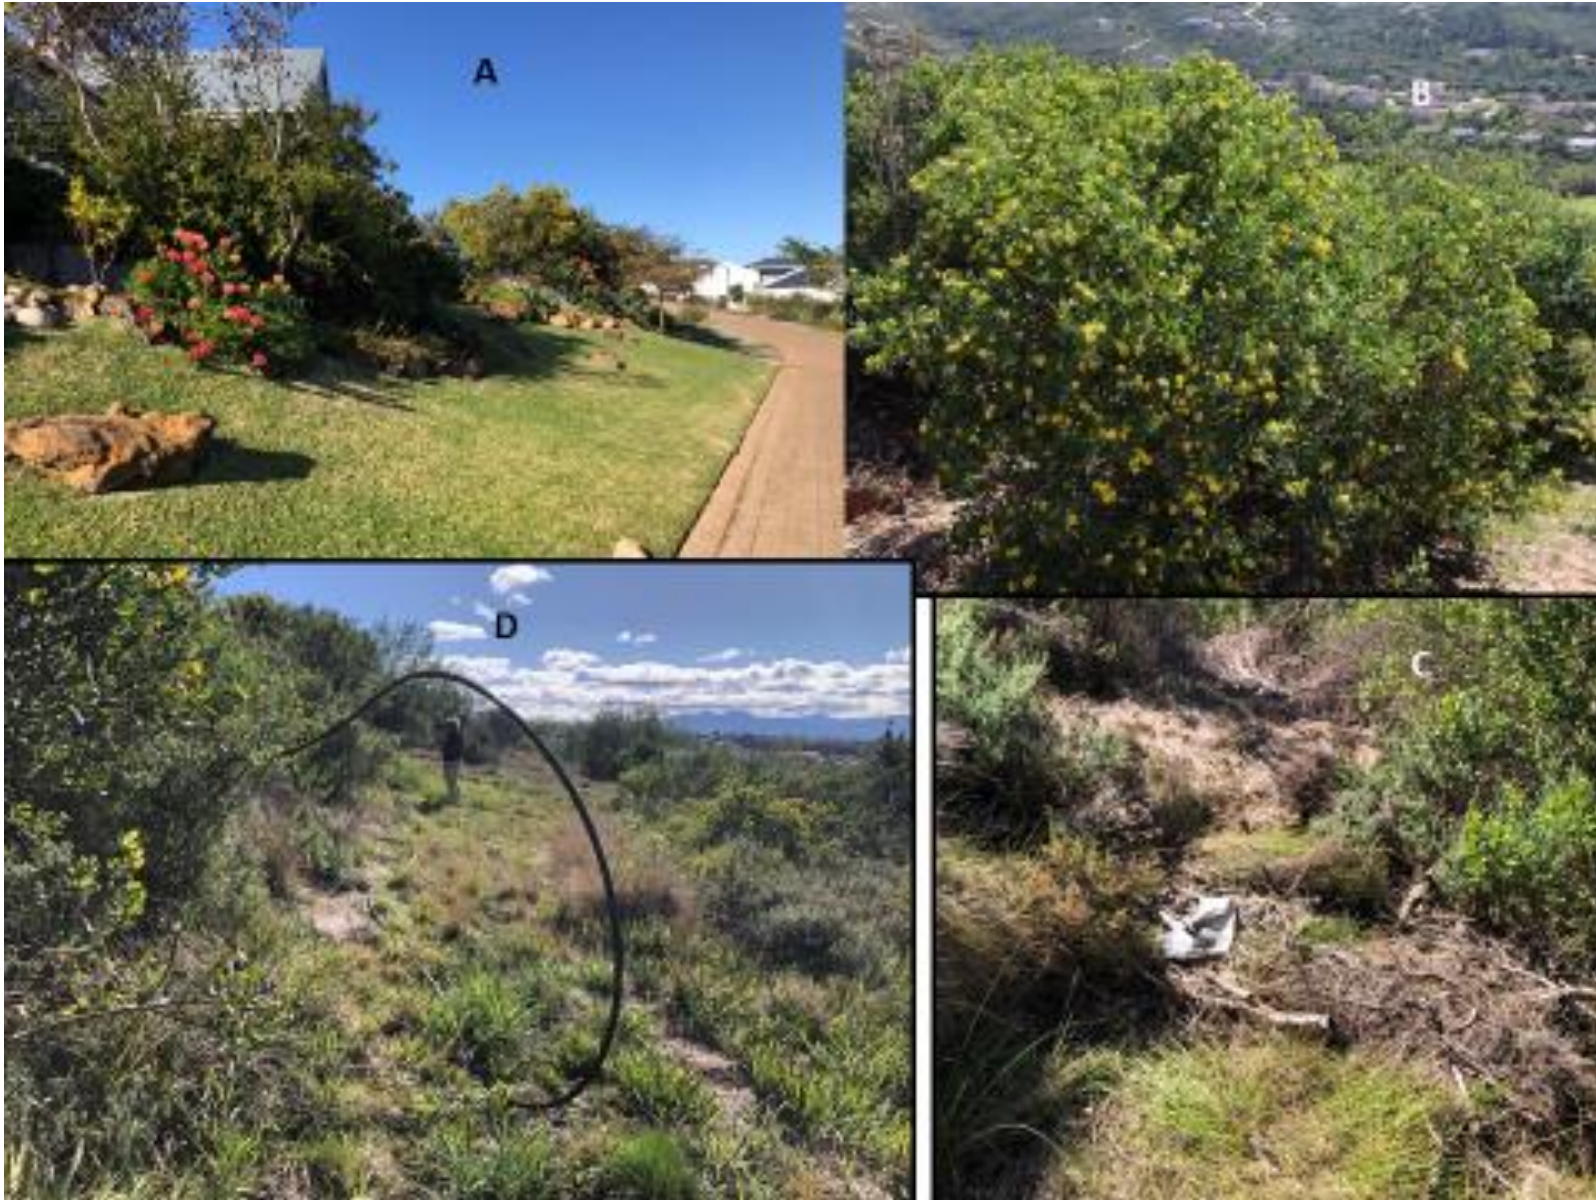
Most of the current landscaping comprises non-local native species or developed Fynbos cultivars and hybrids rather than locally indigenous plant species (Photo panel 4). This is acceptable provided that no closely related species is present in the adjacent vegetation that could hybridize with them, resulting in loss of the wild species' genetic integrity (as has happened with some *Protea* species in other areas, such as Silvermine section of Table Mountain National Park). Kikuyu (*Cenchrus clandestinus*) is an invasive, alien grass and should not be used for lawns. The alternative grass species listed in the landscaping guidelines: Kweek (*Cynodon dactylon*) or Buffalo (*Stenotaphrum secundatum*) should be used instead.

I noted some incidents of garden waste being dumped over garden walls into the natural open space areas (Photo panel 4). This should not be allowed as this material smothers the Fynbos vegetation and may include weed seeds in lawn cuttings. I also came across a long black pipe that ran from a private garden into the open space areas (Photo panel 4, above Orchid Valley). It is not clear what this pipe was for, but the OEMP (2021) states that swimming pool water may not be released into the open spaces and should be directed into the storm water system.

Photograph panel 4. Illustrates A. Typical garden landscaping using cultivars or hybrids of Fynbos species; Invasive Bietou (*Osteospermum moniliferum*); C. dumping of garden refuse into the open space; D. A plastic pipe running into the open space.

Directives:

- Update the landscaping plant list to remove species such as Bietou which invade the natural open space areas.
- Raise awareness among the homeowners about fire-proofing their properties with suitable landscaping, e.g., in the 2 m against buildings and boundaries with natural vegetation. Flammable garden species may not be planted in such areas.
- Warn homeowners not to dump garden waste into the natural open space areas and check for compliance.
- Advise homeowners not to extend gardens into natural open space areas, including fire belts, and check for compliance.
- Ensure that swimming pool waste water is not released directly into natural open space areas.
